DEPARTMENT OF TRANSPORTATION

Quality Assurance and Source Inspection

Contract #: 04-0120F4Cty: SF/ALA Rte: 80 PM: 13.2/13.9File #: 69.28**WELDING INSPECTION REPORT****Resident Engineer:**Pursell, Gary**Address:** 333 Burma Road**City:** Oakland, CA 94607**Report No:** WIR-009305**Date Inspected:** 26-Sep-2009**Project Name:** SAS Superstructure**OSM Arrival Time:** 645**Prime Contractor:** American Bridge/Fluor Enterprises, a JV**OSM Departure Time:** 1745**Contractor:** Zhenhua Port Machinery Company, Ltd (ZPMC), Changxing Island **Location:** Shanghai, China**CWI Name:** Chen Ying Xin.**CWI Present:** Yes No**Inspected CWI report:** Yes No N/A**Rod Oven in Use:** Yes No N/A**Electrode to specification:** Yes No N/A**Weld Procedures Followed:** Yes No N/A**Qualified Welders:** Yes No N/A**Verified Joint Fit-up:** Yes No N/A**Approved Drawings:** Yes No N/A**Approved WPS:** Yes No N/A**Delayed / Cancelled:** Yes No N/A**Bridge No:** 34-0006**Component:** Tower Components**Summary of Items Observed:**

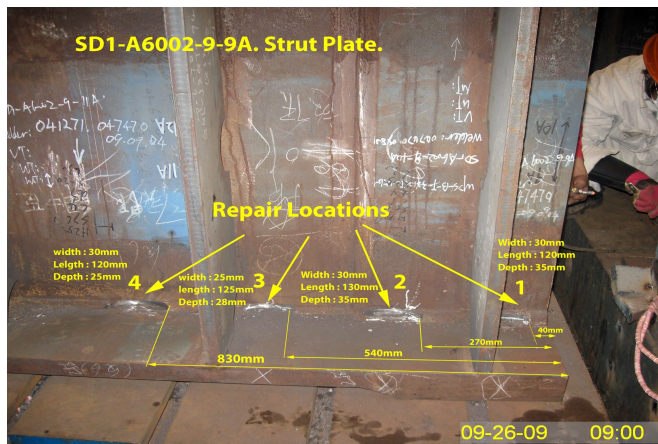
Bay10, South Tower, Struts Repair.

Repair gouge out noticed on strut weld Identified as SD1-A6002-9-9A. see attached picture for details.
